DOE/NV--1191

Post-Closure Inspection Report for
Corrective Action Unit 92:
Area 6 Decon Pond Facility,
Nevada Test Site, Nevada
For Calendar Year 2006

March 2007

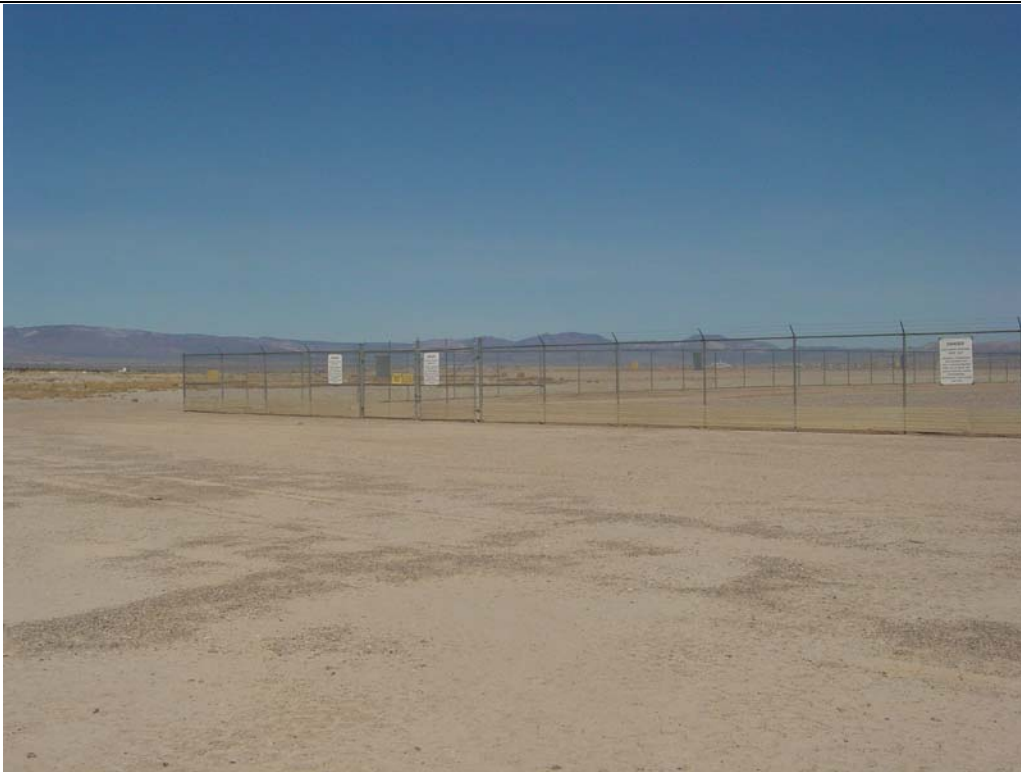
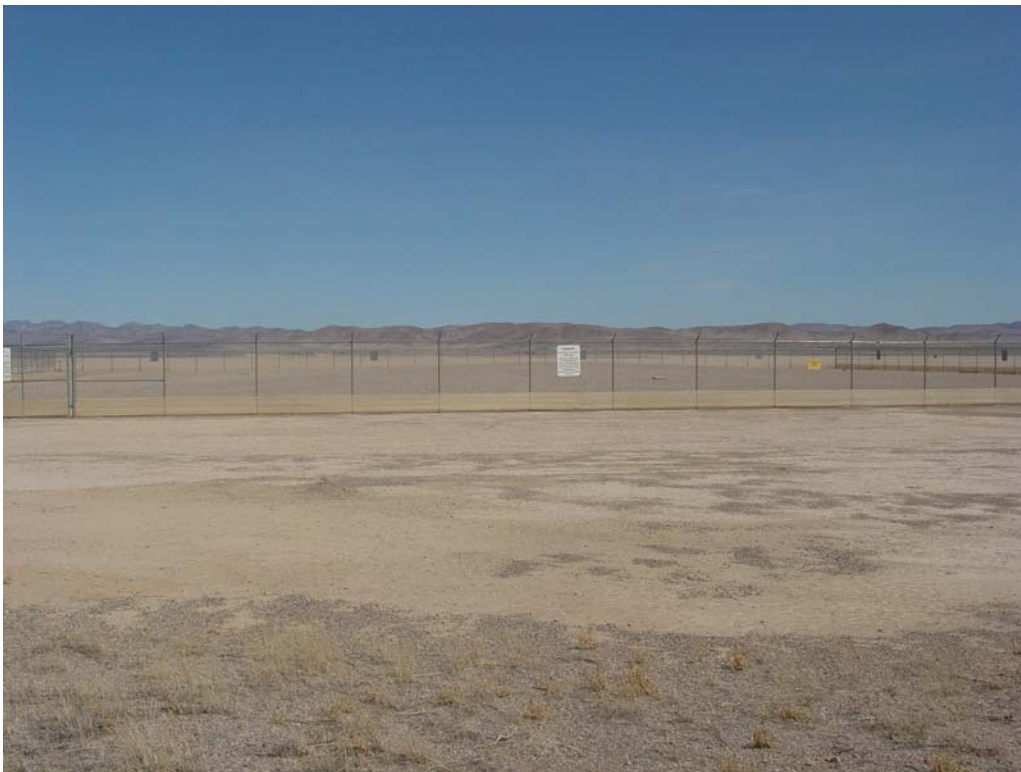
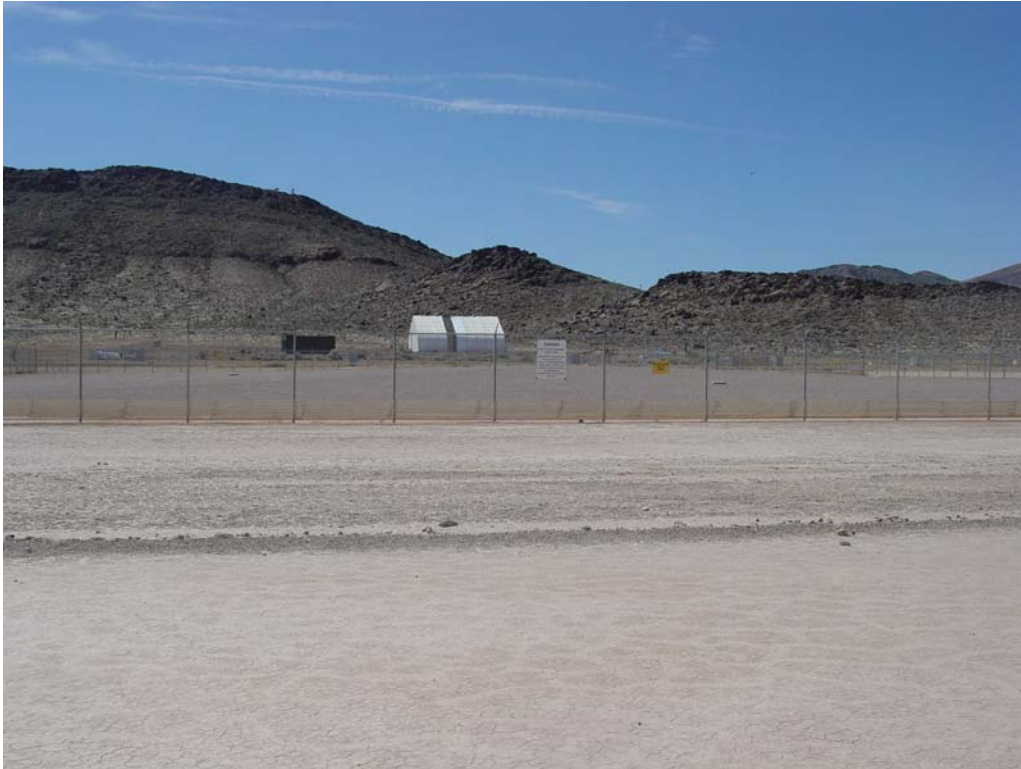
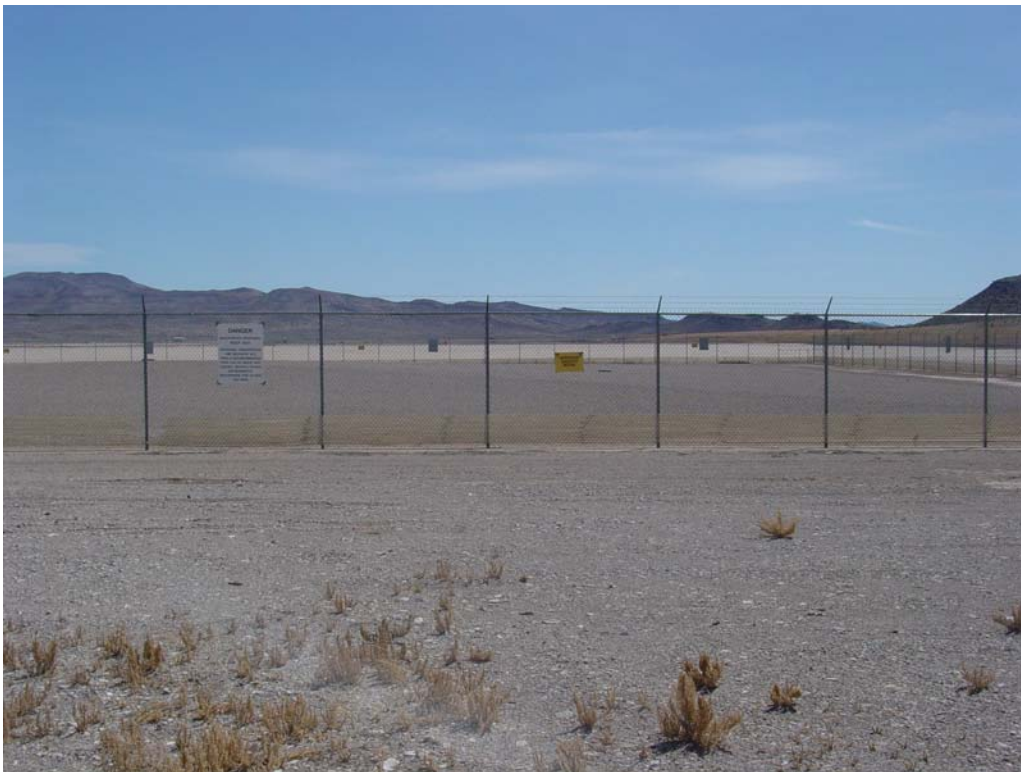
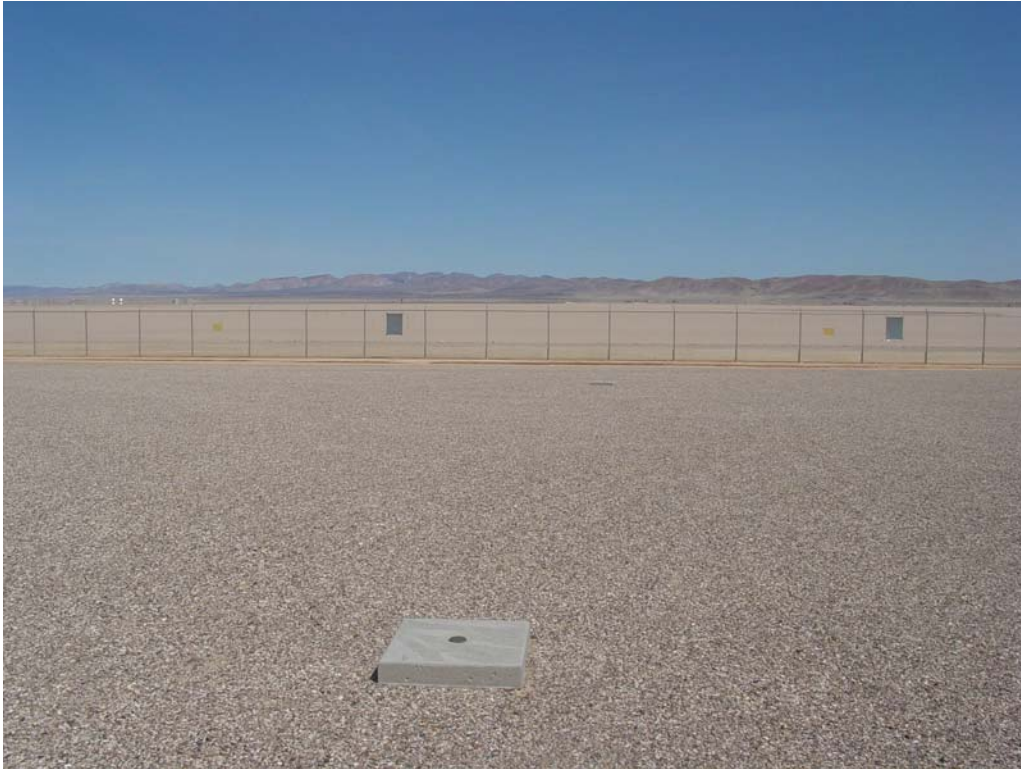
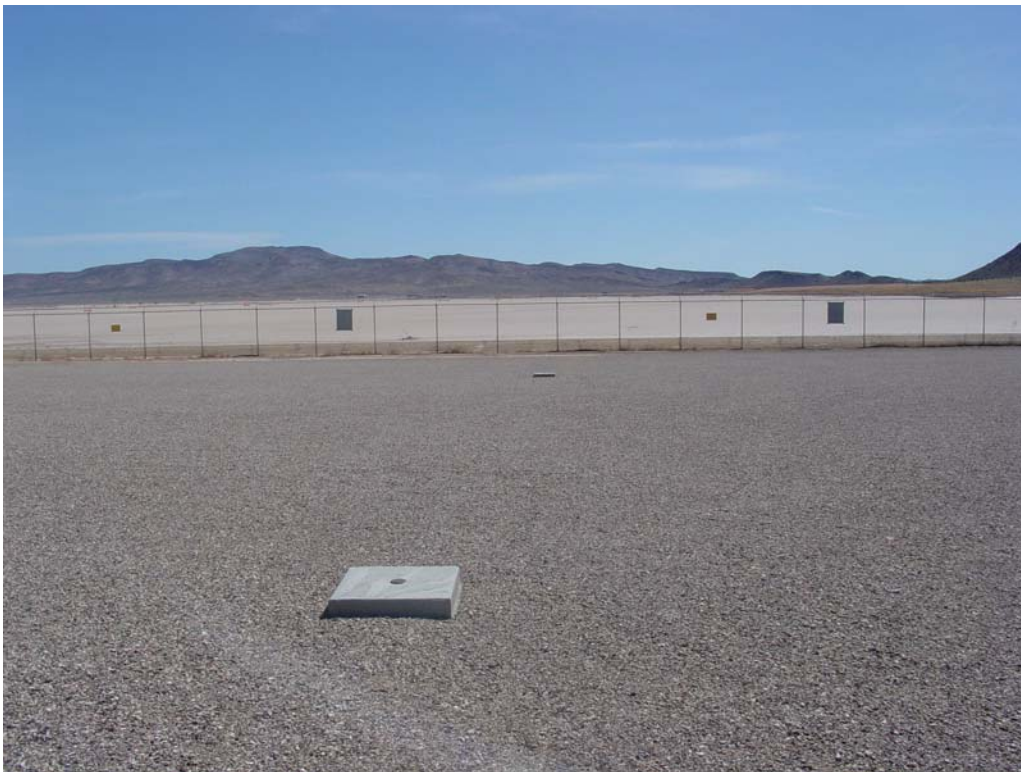
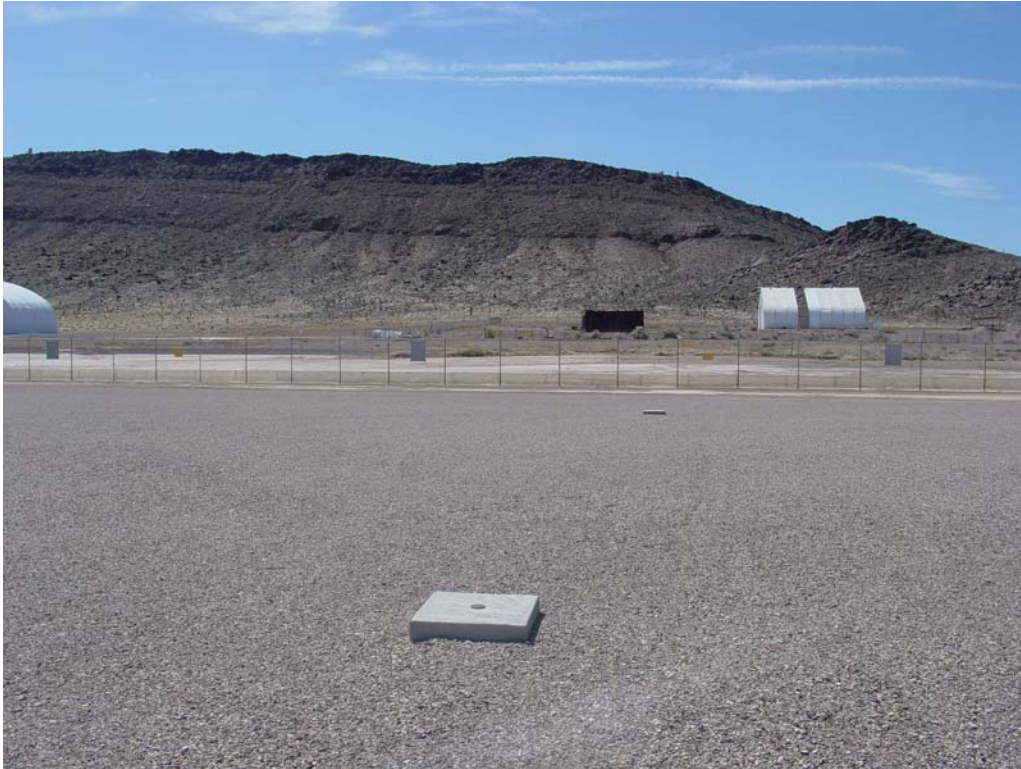
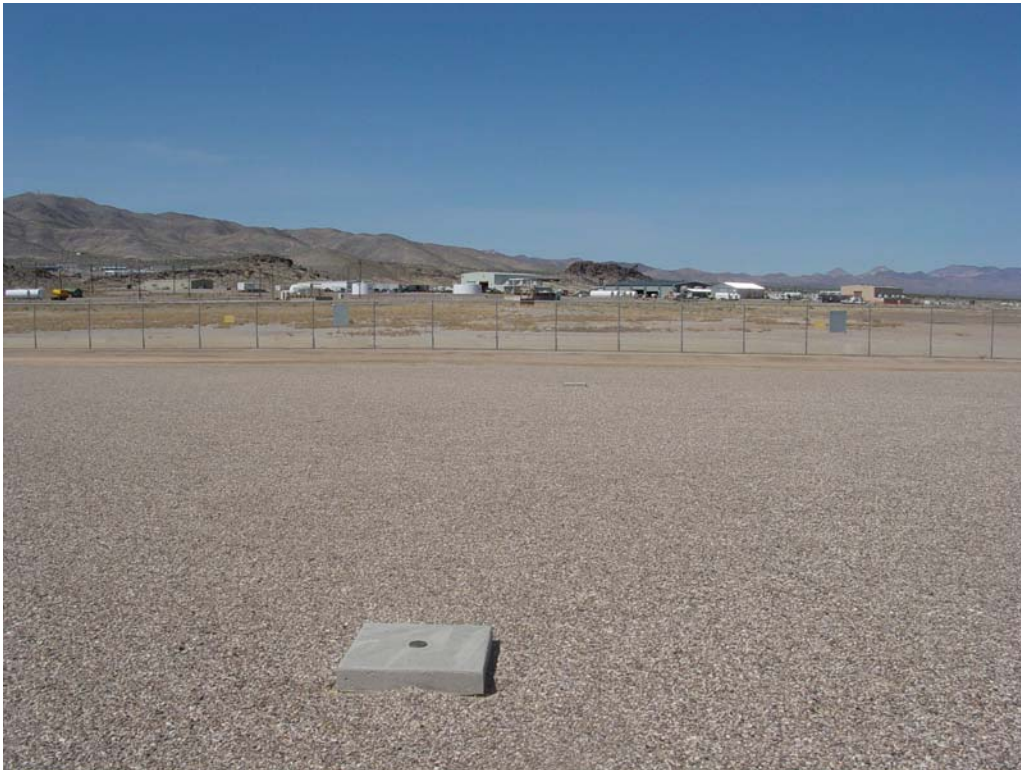
The first quarter inspection was conducted on March 23, 2006. The inspection indicated that the unit was in excellent condition. No issues were identified with the fence, signs, monuments, or cover.

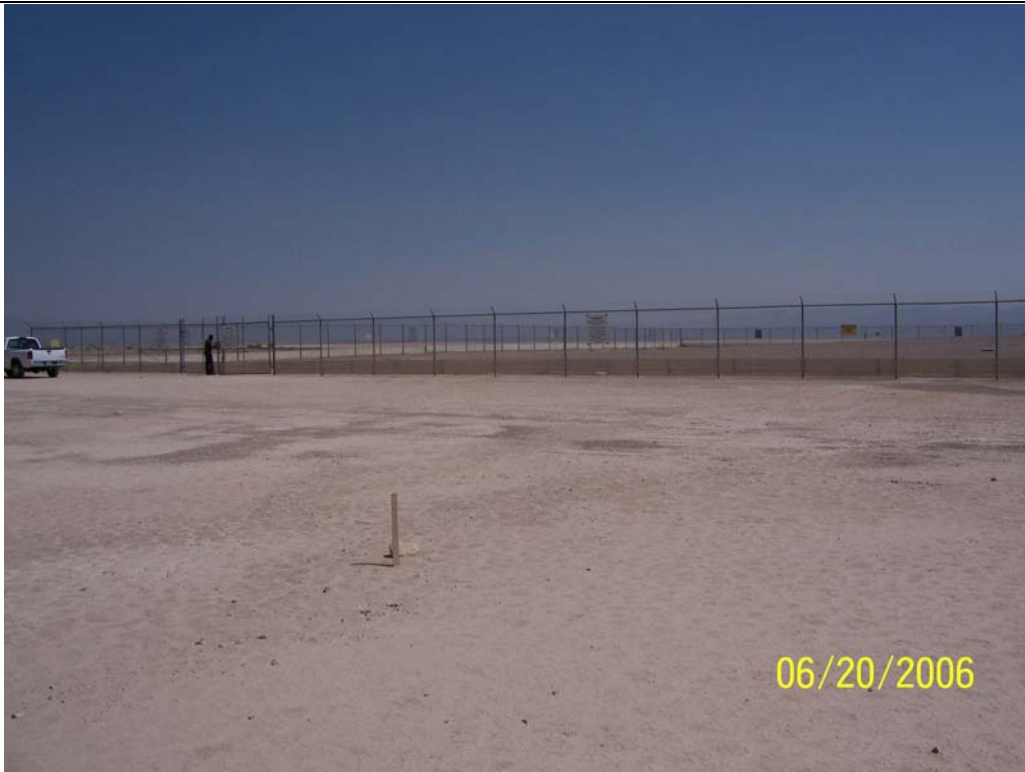
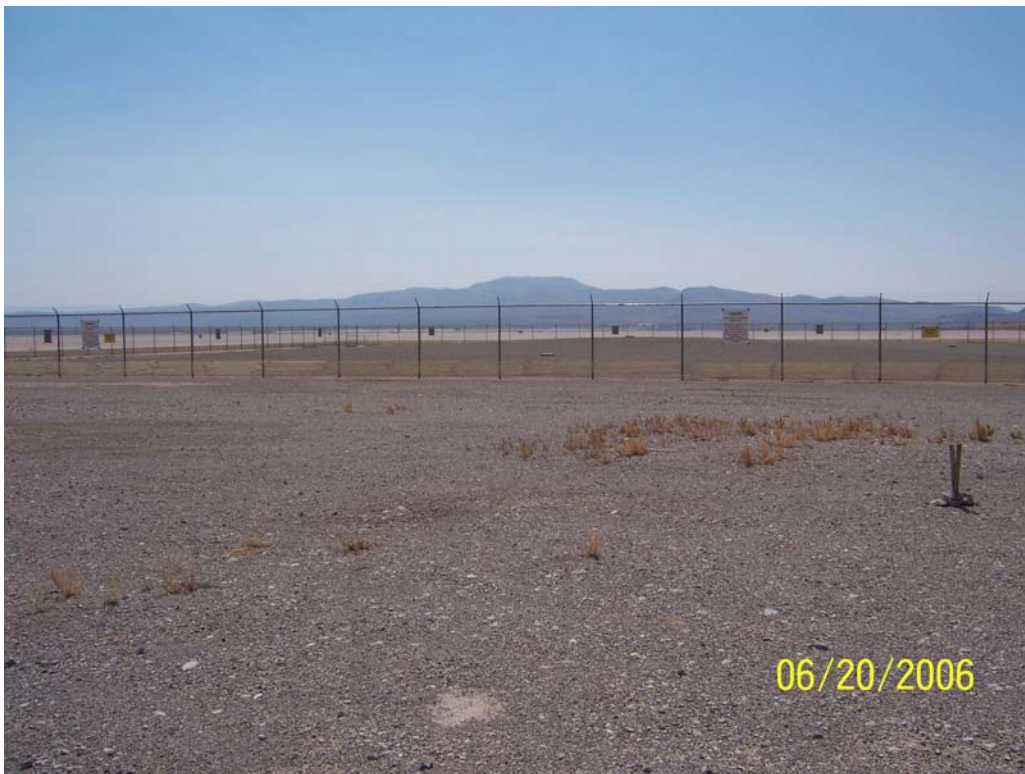
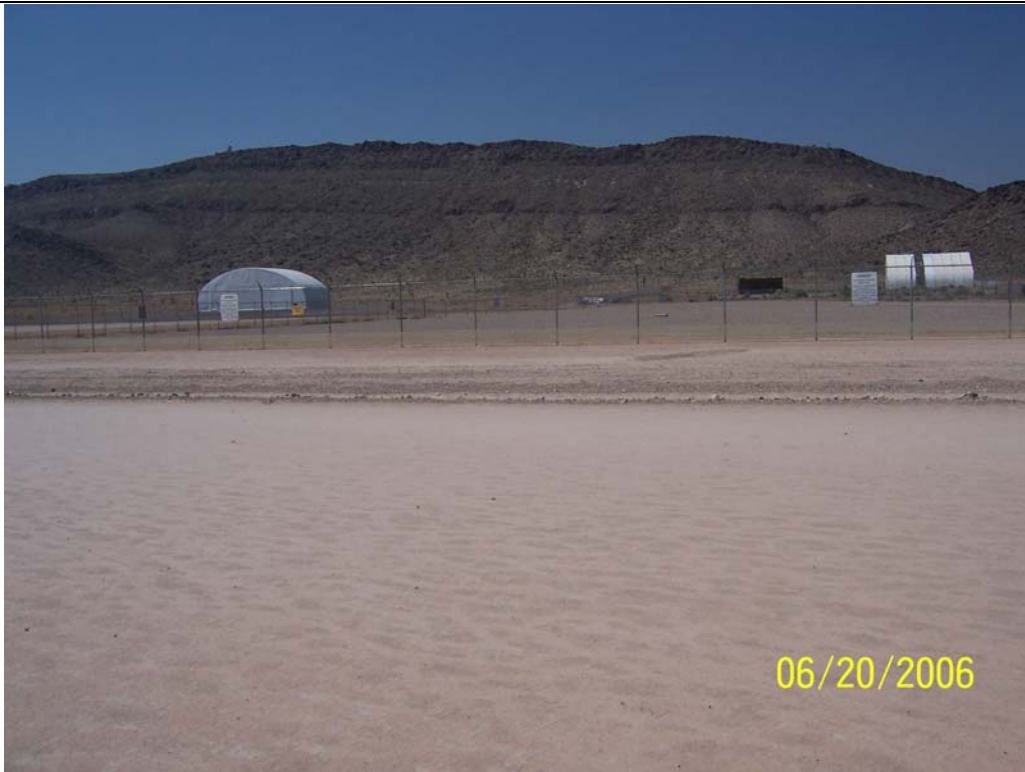
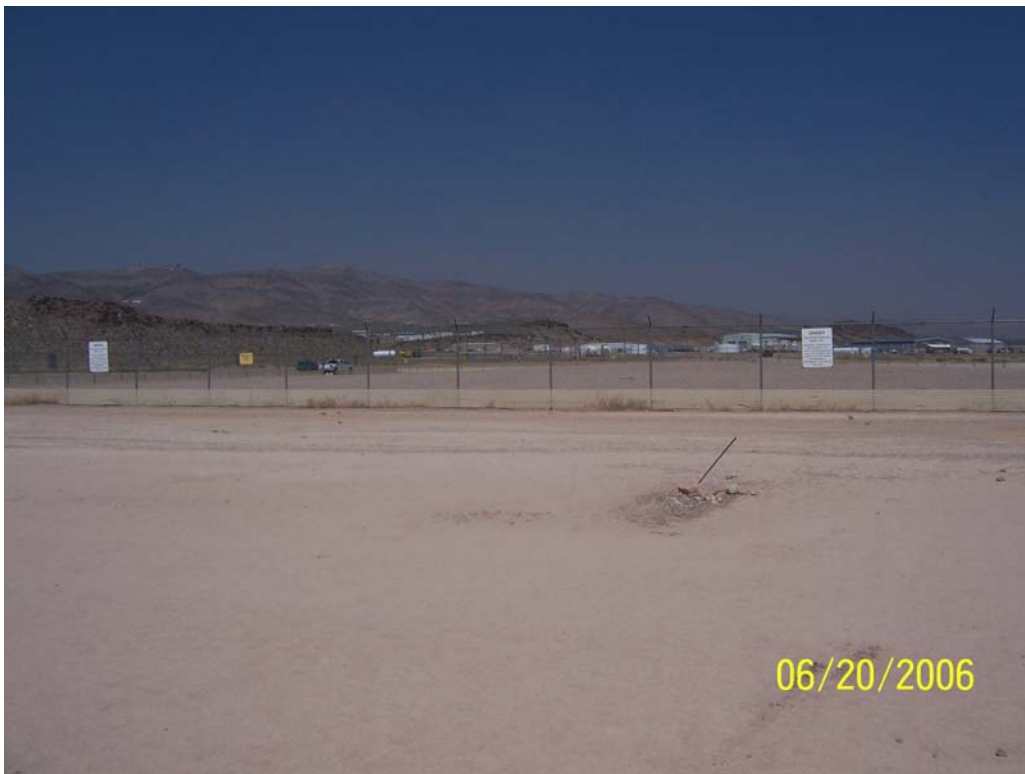
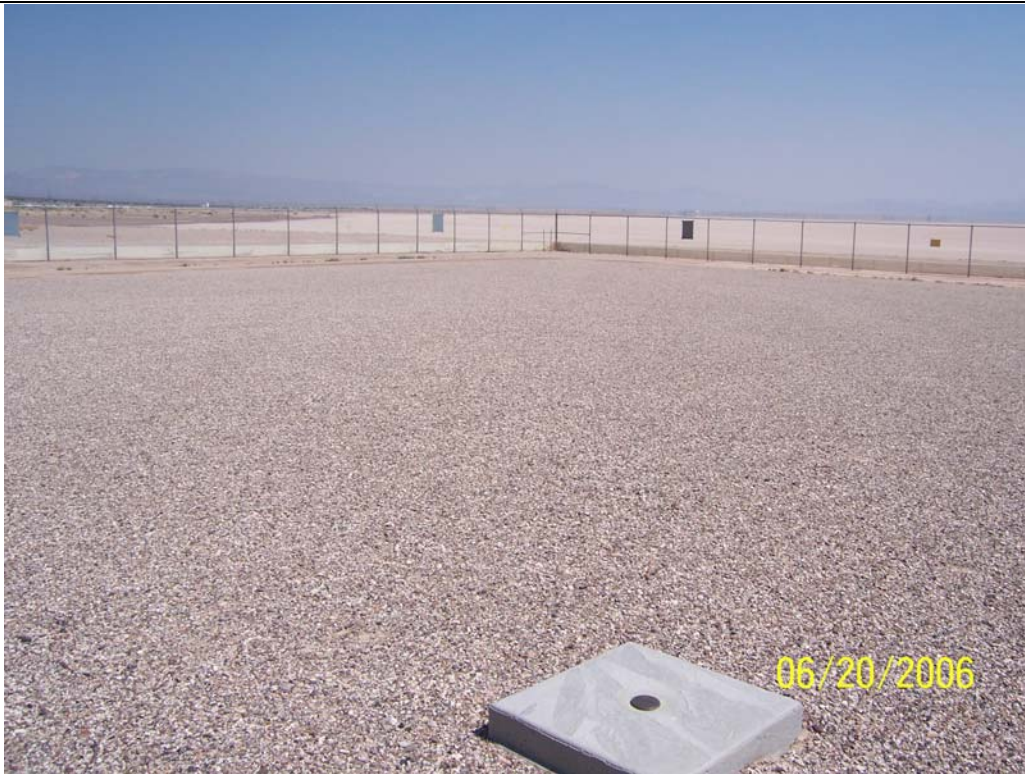
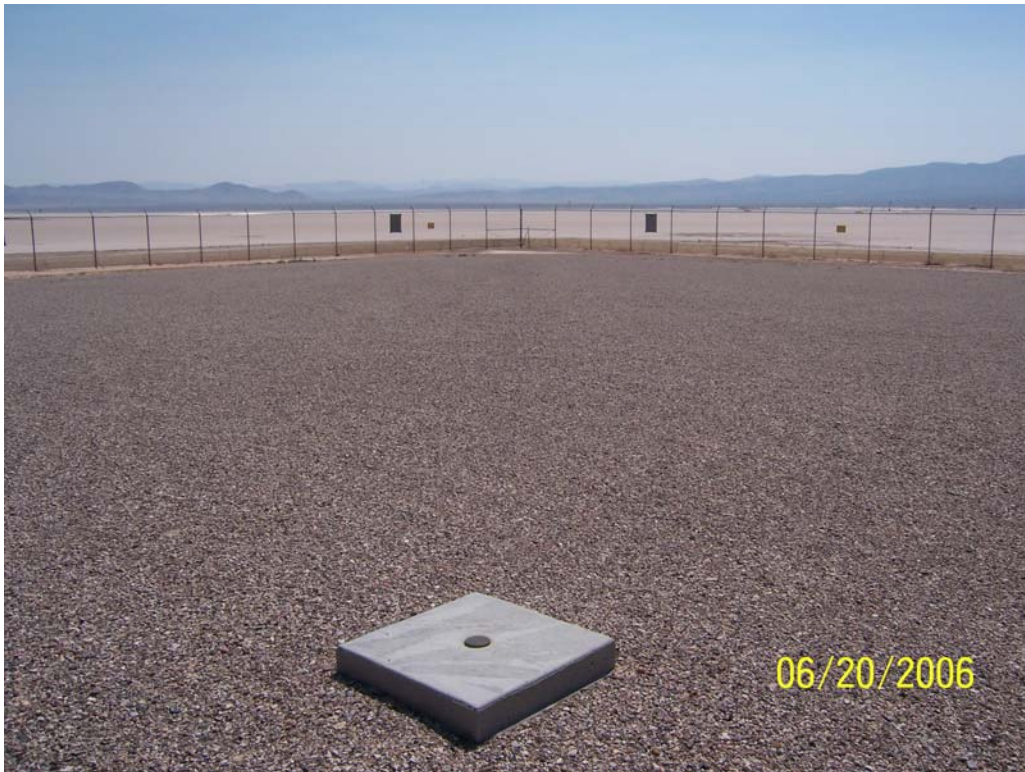
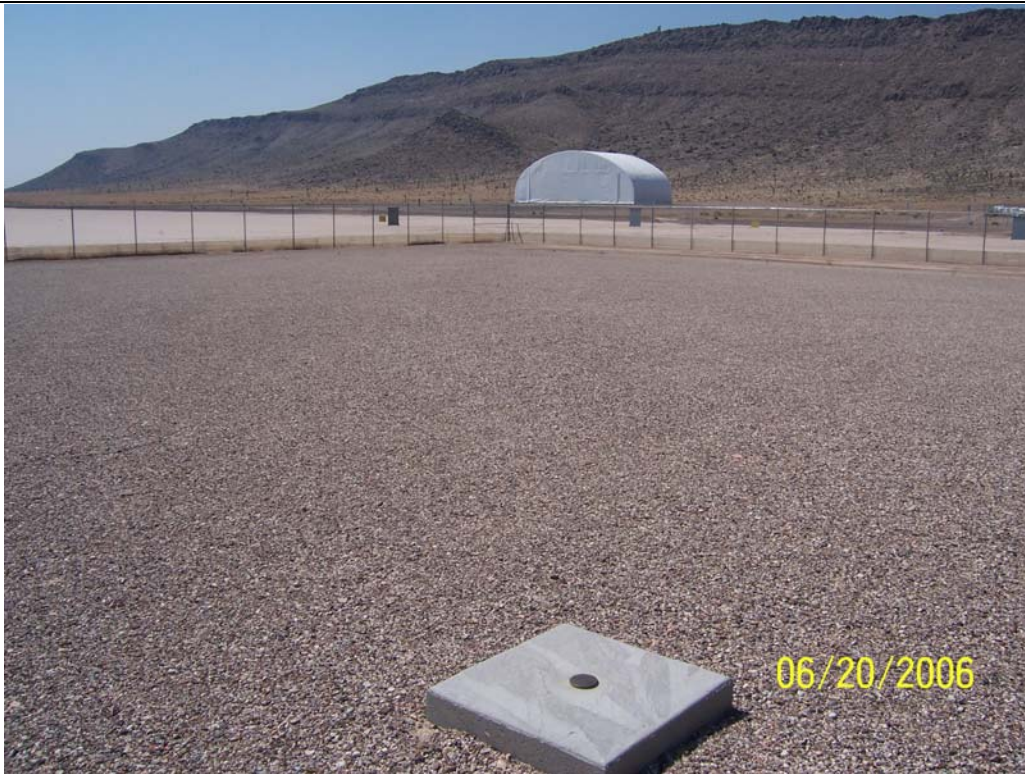
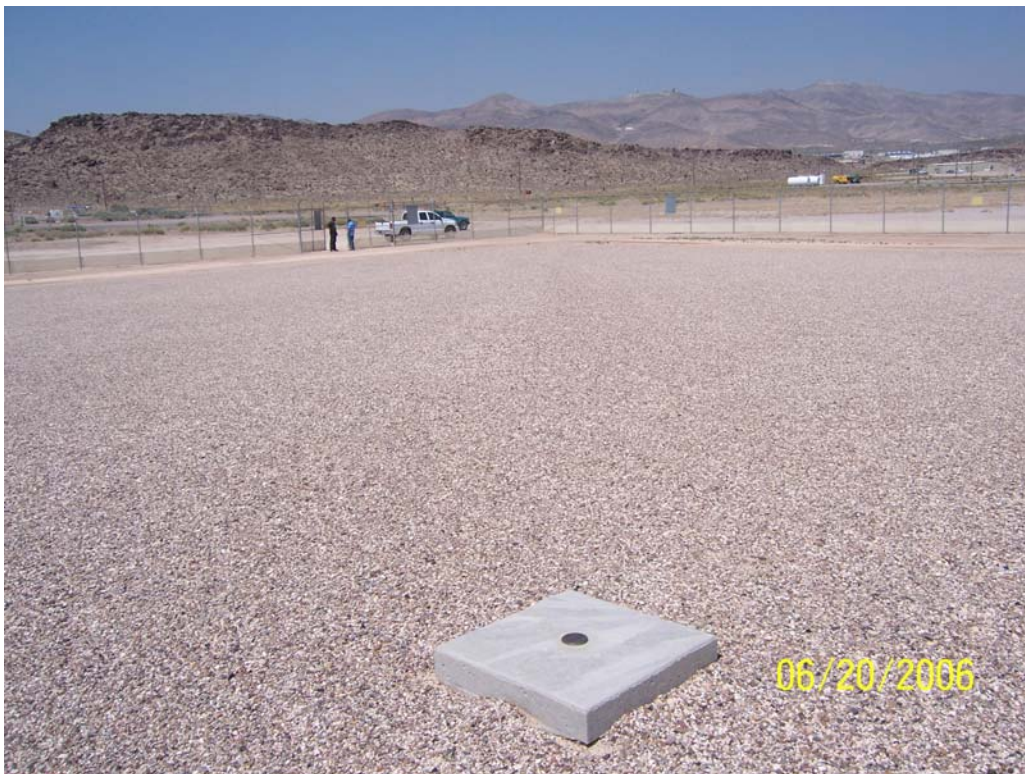
The second quarter inspection was conducted on June 20, 2006. The inspection indicated that the unit was in excellent condition. No issues were identified with the fence, signs, monuments, or cover. Some minor vegetation growing on the edge of the cover was noted.

All observations indicated the continued integrity of the unit; however, as a best management practice, it was recommended to remove the vegetation that was growing on the edge of the cover.

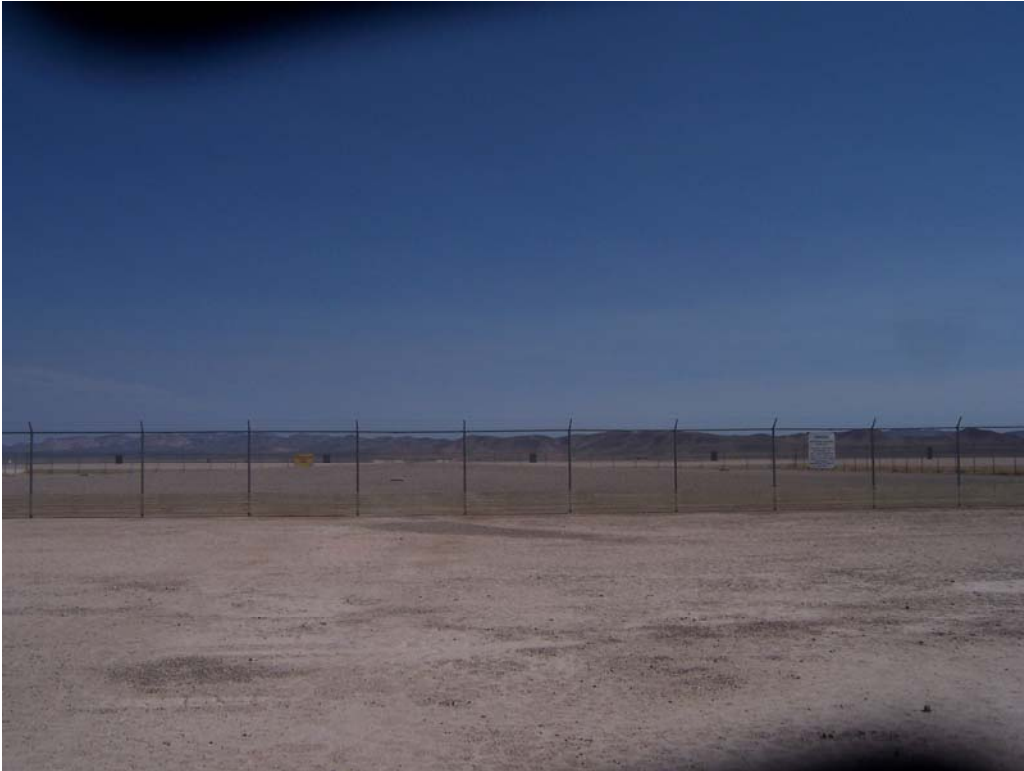
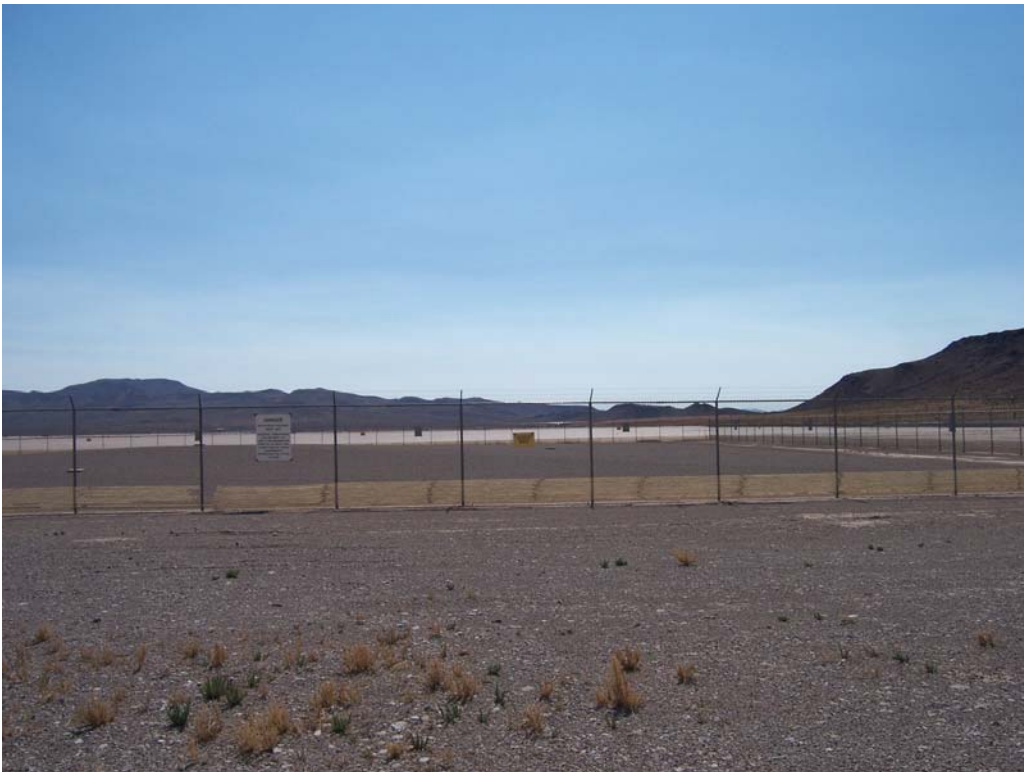
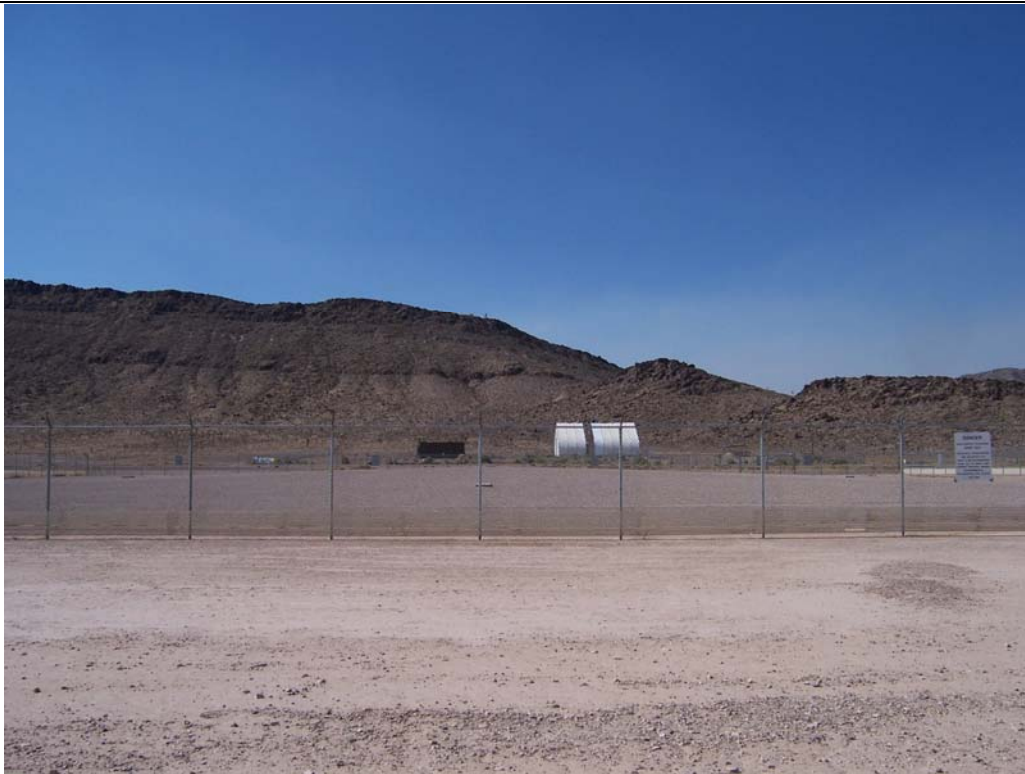
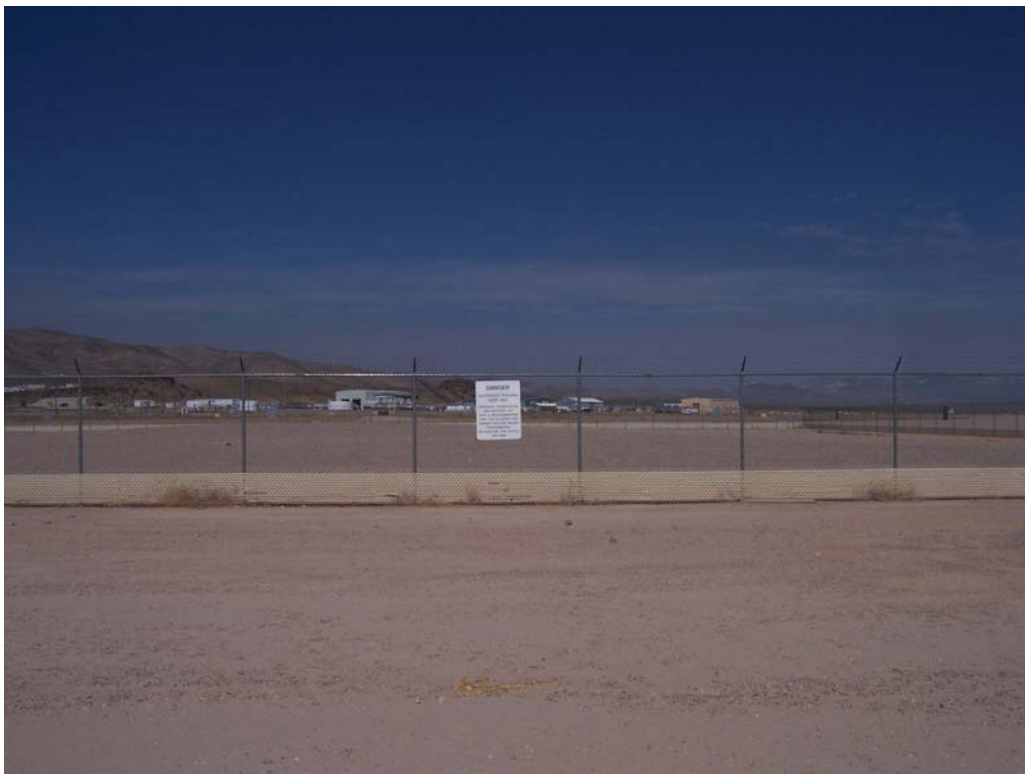
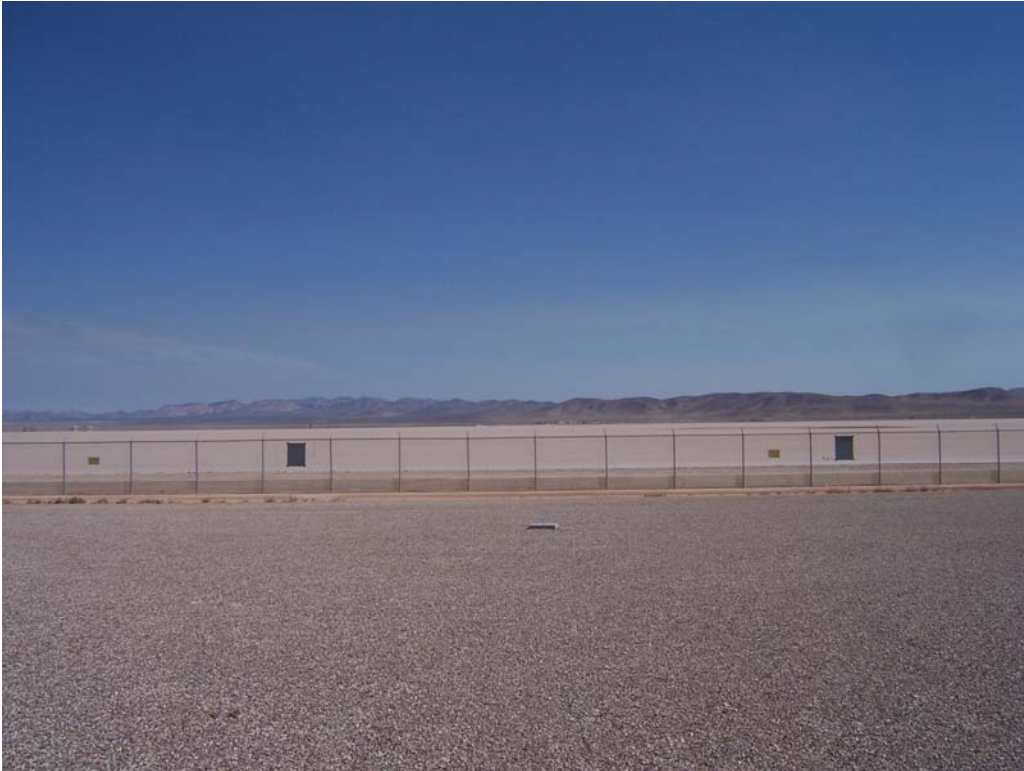
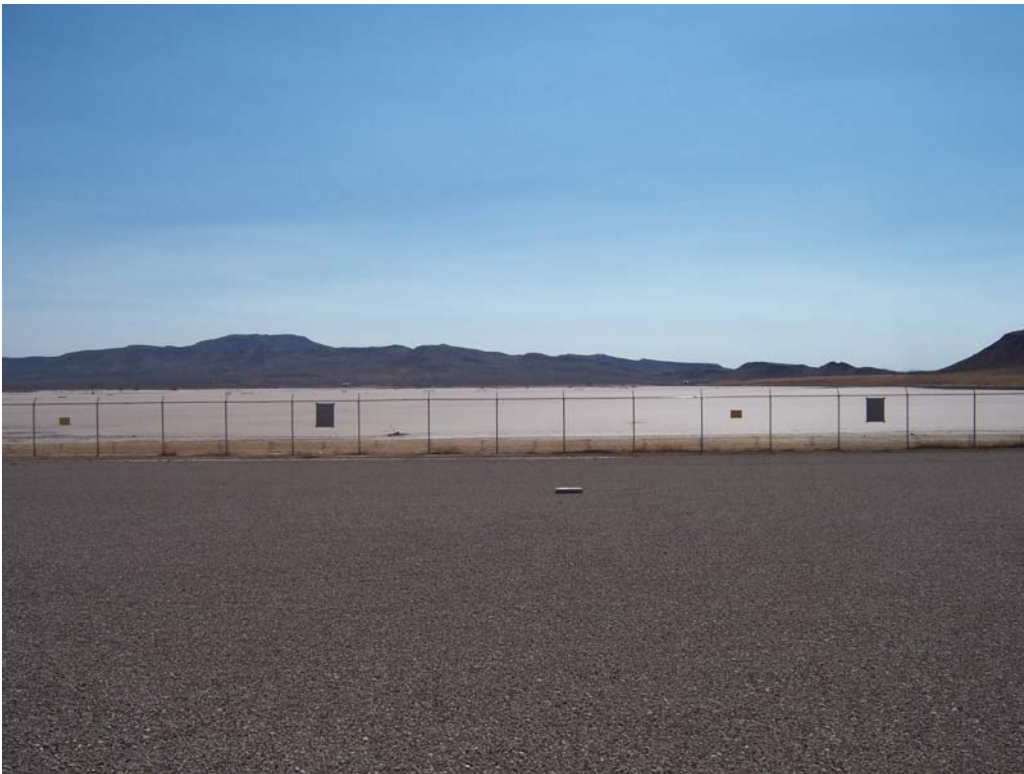
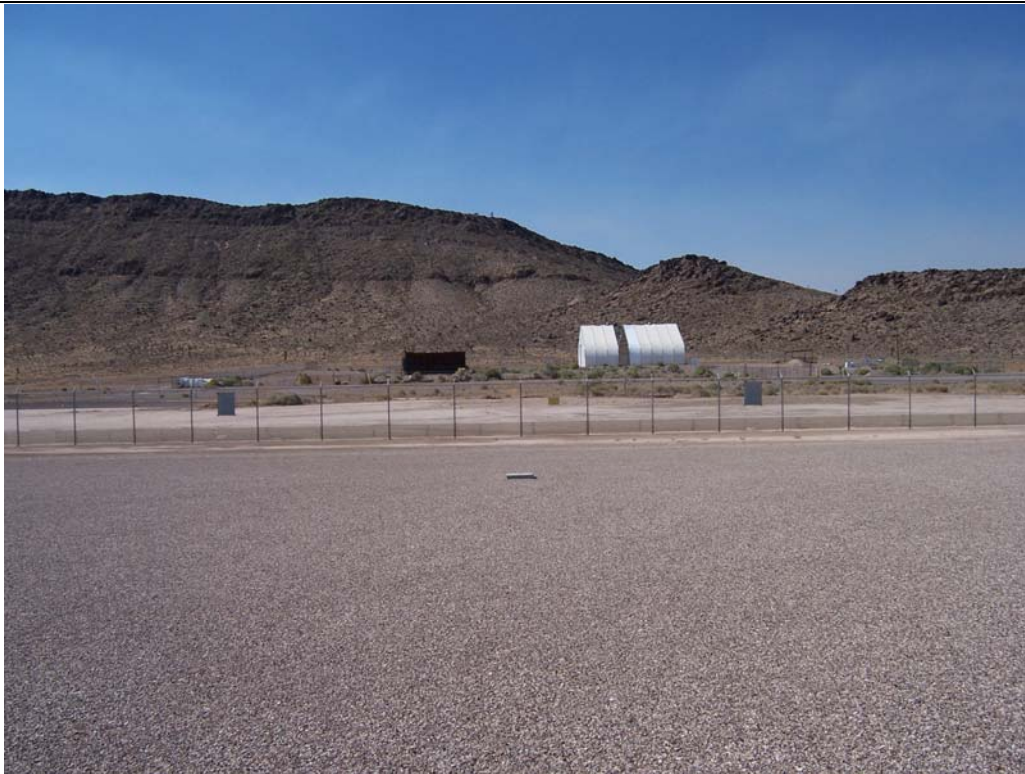
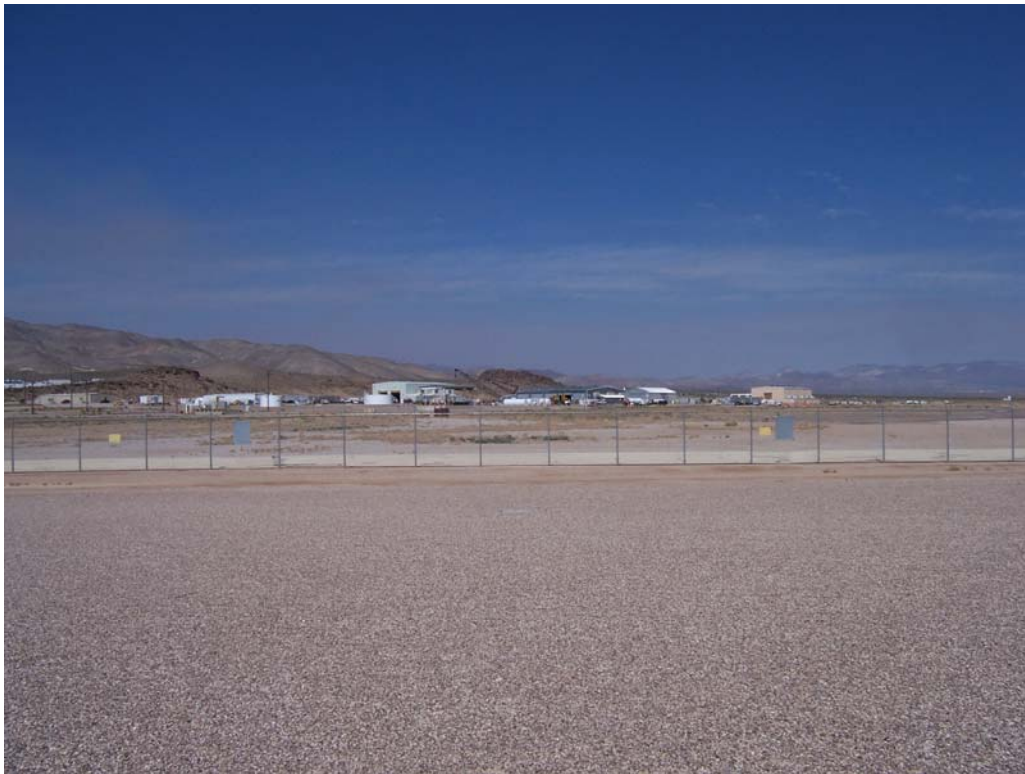
The third quarter inspection was conducted on September 19, 2006. The inspection indicated that the unit was in excellent condition. No issues were identified with the fence, signs, monuments, or cover. Vegetation growing on the edge of the cover had been removed as a best management practice on August 3, 2006.
